# **DP-50**

# **DIAMOND PIER<sup>®</sup>**

## **FROST PERFORMANCE REPORT**

**Zone II, Minnesota Soils**

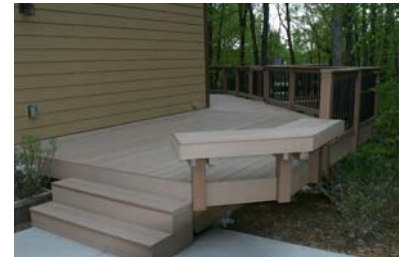
The main deck is roughly 11 feet by 33 feet and 10 feet in height. Three piers have been installed in a straight line along a common beam located approximately 11 feet from the house. Additional piers support a walkway from the structure to the driveway on the side of the house and a landing and stairway off the corner of the structure. A total of ten Diamond Piers are installed.

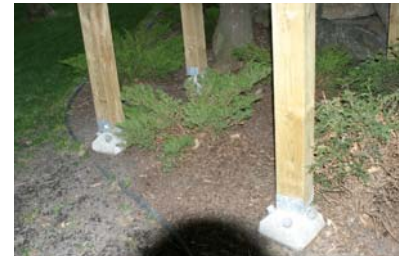
Observation of the soil and proximity to the Barras home described above indicates the soils are hard packed clay.

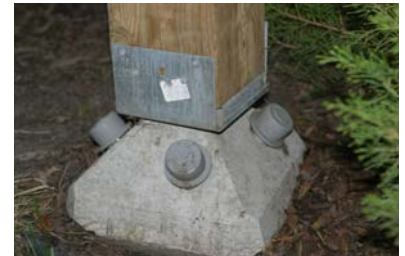
The Diamond Piers were reviewed for distress around the pin sleeves or if the pins have moved relative to the pier. No signs of distress or cracking were observed. All pins project consistently from the Diamond Piers. A sampling of the pins indicates none are loose and a measurement down the inside indicates the pins are 50 inches long. An 8-inch bullet level was used to measure the levelness of the Diamond Pier. All were level. The post connection brackets were secure and fully seated on all Diamond Piers.

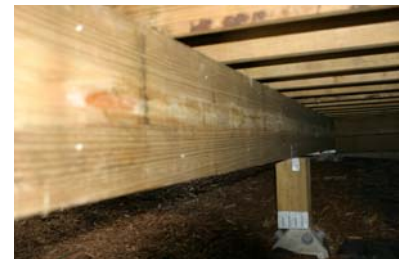
A 4-foot level was used to check the levelness of the deck. All posts are plumb and the main supporting beam between the piers is level and tightly secured to the posts. There are no indications of differential movement between the piers.

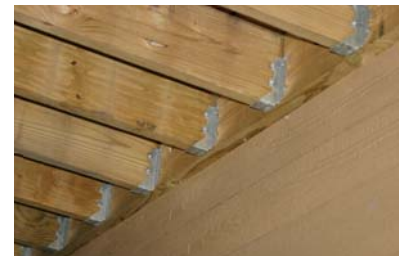
The joists are level and the ledger board connecting to the house was reviewed. All of the joist brackets are secure and no sign of prying is apparent.

**There are no indications of any foundation movement or degrading of the structure.**

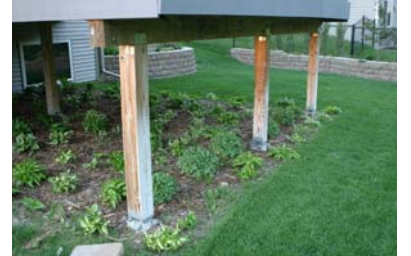
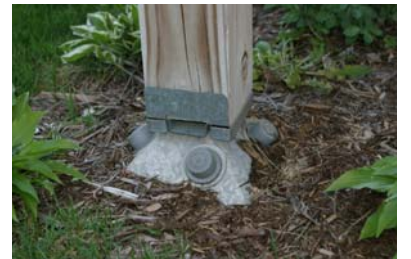
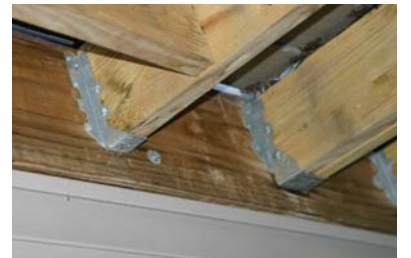
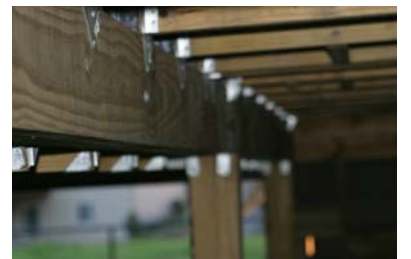
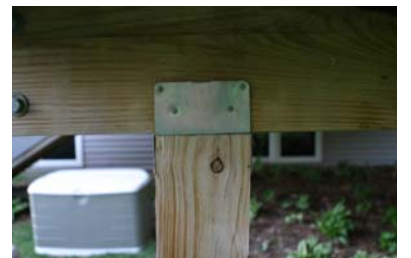
The Diamond Piers were reviewed for distress around the pin sleeves or if the pins have moved relative to the pier. No signs of distress or cracking were observed. All caps covering the ends of the pins have been sealed to the concrete. The homeowner stated 48 inch pins were used on the project.

All Diamond Piers were level and the post connection brackets were secure and flat against the top of the pier. A 4- foot level was used to check the levelness of the joists and supporting beams. All posts are plumb and the supporting beams between the piers are level and tightly secured to the posts. I observed that the perimeter beam appears to have rolled slightly at the southeast end. The homeowner acknowledges that this occurred during construction because he had not joined the two plies of the beam together and the bracket at the top of the post bent. He has added a third ply to the beam and thru bolted all three members along the length of the beam. There is no indication of differential movement between the posts on either beam line.

The joists are level and the hangers at the ledger board attached to the home are tight. No prying was apparent.

**There are no indications of any foundation movement or degrading of the structure.**

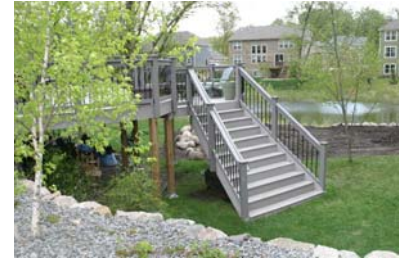
The main deck is roughly 22 feet by 14 feet and 12 feet in height. Three piers have been installed in a straight line along a common beam located approximately 13 feet from the house. Three additional piers support a walkway from the structure to the driveway on the side of the house and six piers support an octagonal landing leading to a stairway off the corner of the structure.

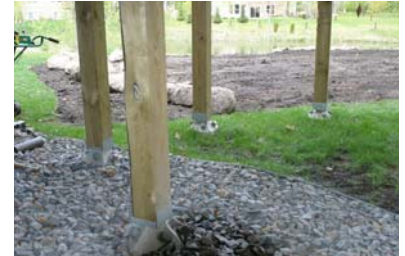
The homeowner reported drainage problems at the side yard of the property where water draining from the driveway ponds at the corner of the deck near the stairway. The homeowner was in the process of re-grading the site and adding a drain tile to drain the area. A shallow hole was dug nearby and the soils appear to be hard packed clay.

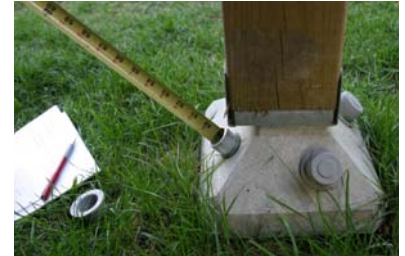
The Diamond Piers were reviewed for distress around the pin sleeves or if the pins have moved relative to the pier. No signs of distress or cracking were observed. Two pins of forty-eight on the site projected approximately 3/4" to 1" above the concrete while the remaining pins projected consistently from the Diamond Pier. A sampling of the pins indicates none are loose and measurements down the inside indicate the pins are 50 inches long. I used an 8-inch bullet level to measure the levelness of the Diamond Pier. All were level. The post connection brackets were secure and fully seated on all Diamond Piers.

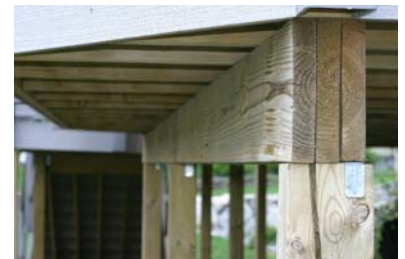
I used a 4-foot level to check the levelness of the deck. All posts are plumb and the main supporting beam between the piers is level and tightly secured to the posts. There are no indications of differential movement between the piers.

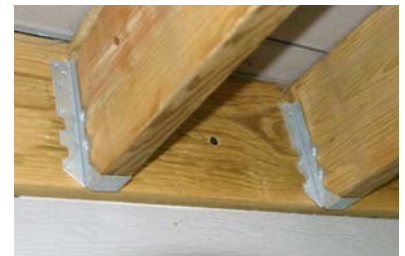
The joists are level and the ledger board connecting to the house was reviewed. All of the joist brackets are secure and no sign of prying is apparent.

**There are no indications of any foundation movement or degrading of the structure.**

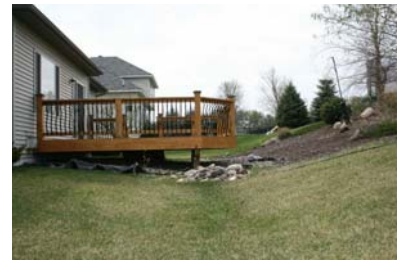
The deck in question is roughly 16 feet by 20 feet and 2 feet in height. Three piers support a common beam installed 14 feet from the house. The yard slopes towards the house and the homeowner reports that water saturates the soil around and under the deck as it drains from the hillside. The homeowner reports the site drains quickly and the soil is sandy and no water enters the basement of the house after heavy rains.

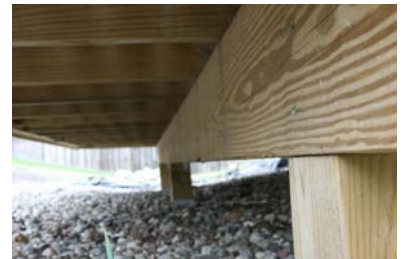
The piers were buried underground and the low deck made access difficult. I was able to observe one pier and its pins. The pier was not damaged and the pin projection is consistent with that found on other projects. None of the pins are loose and a measurement down the inside indicates 63 inch pins were used on the project.

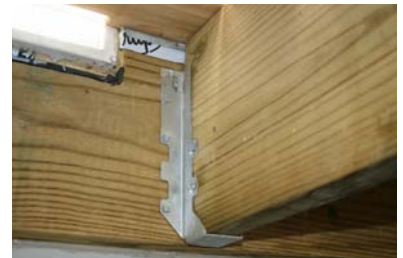
A 4-foot level was used to check the levelness of the deck. The joists and decking are level, as is the crossbeam. The posts are tight to the pier and beam. I was able to observe the ledger beam from each end. The hangers at the ledger board attached to the home are tight. All hangers appeared to be tight to the ledger board.

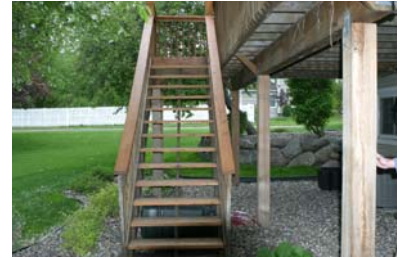
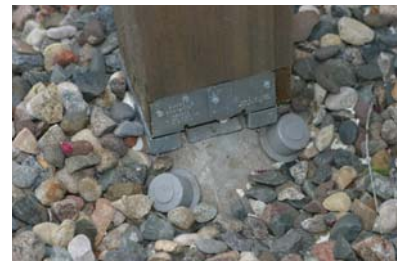
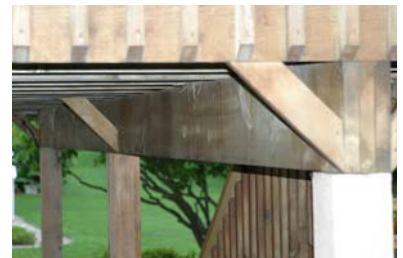
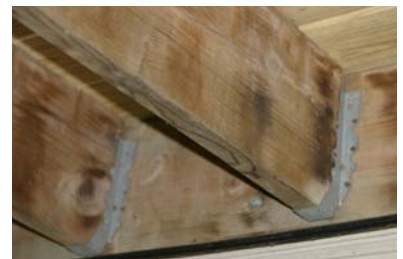
The piers were all installed level and the pins project consistently from each pier. One pier has a slight spall around one pin. No cracking was observed. None of the pins are loose and a measurement down the inside indicates 60 inch pins were used on the project.

The post base brackets are level against the pier and the posts are tightly secured. The posts to beam connections are tight and no gaps were observed.

A 4-foot level was used to check the levelness of the deck. The joists and decking are level, as is the supporting beam. The joists are connected to the ledger board using metal joist brackets. The joist brackets are secure and no sign of prying is apparent.

**There are no indications of any foundation movement or degrading of the structure.**

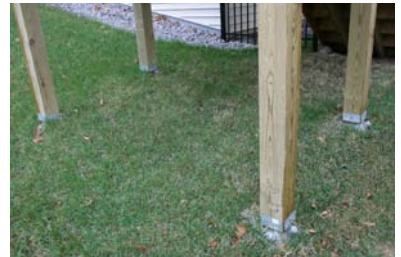
The deck in question is roughly 12 feet by 17 feet and 10 feet in height. Three piers have been installed in a straight line along a common beam located approximately 10 feet from the house. Four additional piers support a stairway from the structure. The site consists of a large engineered fill with a 15-foot tall rock retaining wall. No drainage issues are apparent.

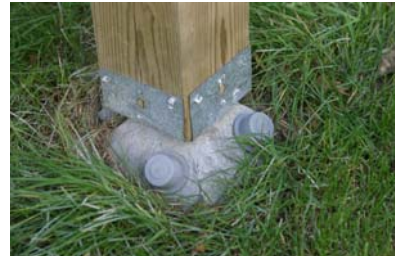
The Diamond Piers were reviewed for distress around the pin sleeves or if the pins have moved relative to the pier. No signs of distress or cracking were observed and all the pins project consistently from the Diamond Pier. A sampling of the pins indicates none are loose and measurements down the inside indicate the pins are 50 inches long. An 8-inch bullet level was used to measure the levelness of the Diamond Pier. All were level. The post connection bracket was secure and fully seated on the Diamond Pier.

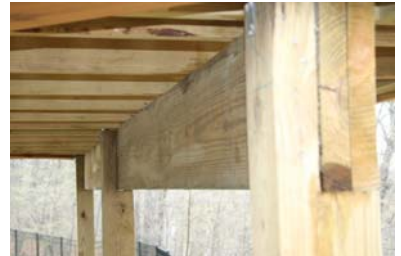
A 4-foot level was used to check the levelness of the deck. All posts are plumb and the supporting beam between the piers is level and tightly secured to the posts. There are no indications of differential movement between the piers.

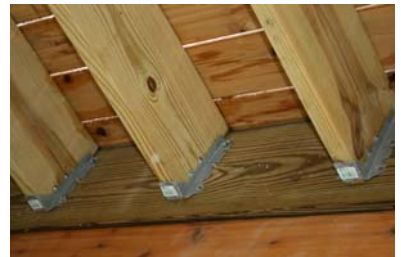
The joists are level sloped slightly away from the house and the ledger board connecting to the house was reviewed. All of the joist brackets are secure and no sign of prying is apparent.

**There are no indications of any foundation movement or degrading of the structure.**

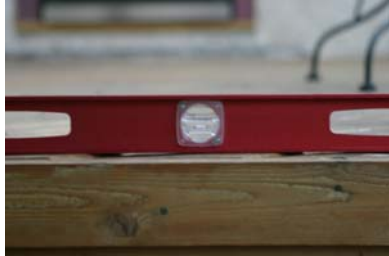
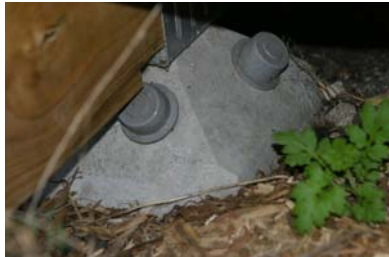
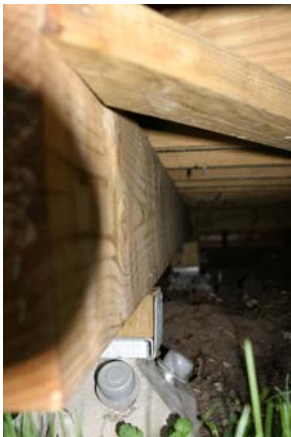
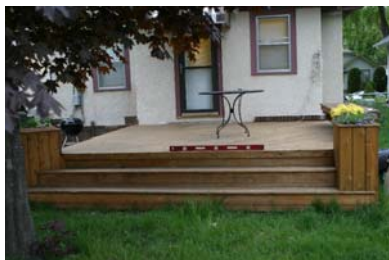
All six piers observed, but access was restricted due to the height and finished sides of the deck. Two piers were reviewed: The first pier closest the house was level and two pin length measurements were taken: one pin length is 17 inches and the other is 29 inches. It appears a short pin was used in order to install the pier close to the house. The second pier was found to be approximately 1/2" out of level and the wood post does not bear fully on its connection bracket. But the post to beam connection was tight indicating that the pier was installed out of level and adjustments were made in the framing. One pin measurement was taken at this pier and the length is 33 inches.

A 4-foot level was used to check the levelness of the deck. The joists and decking are level, as are the supporting beams. No distress was observed in the framing joints, which would indicate that the second pier was installed out of level originally, and the framing compensated for the tilt of the pier.

**There are no indications of any foundation movement or degrading of the structure.**

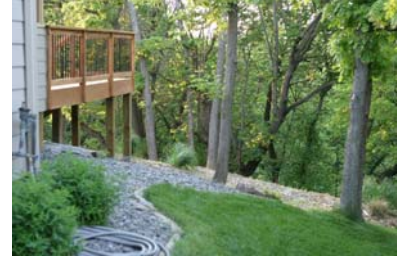
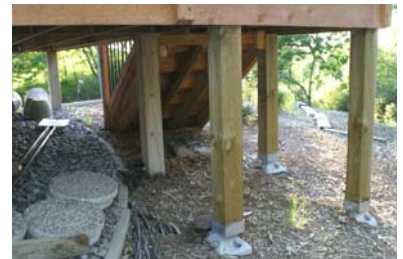
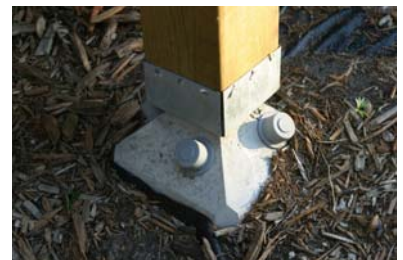
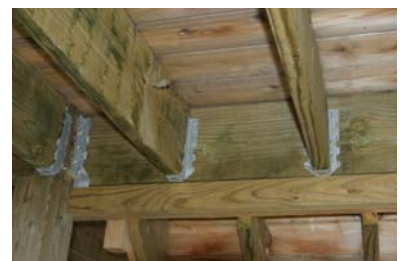
The piers were all installed level and the pins project consistently from each pier. None of the pins are loose and a measurement down the inside indicates 63 inch pins were used on the project. The post base brackets are level against the pier and the posts are tightly secured. The posts to beam connections are tight and no gaps were observed.

A 4-foot level was used to check the levelness of the deck. The joists and decking are level, as is the beam supported at one end by a diamond pier.

**In the portion of the structure supported on Diamond Piers, there are no indications of any foundation movement or degrading of the structure.**
