# **DP-50**

# **DIAMOND PIER<sup>®</sup>**

## **FROST PERFORMANCE REPORT**

**Zone II, Minnesota Soils**

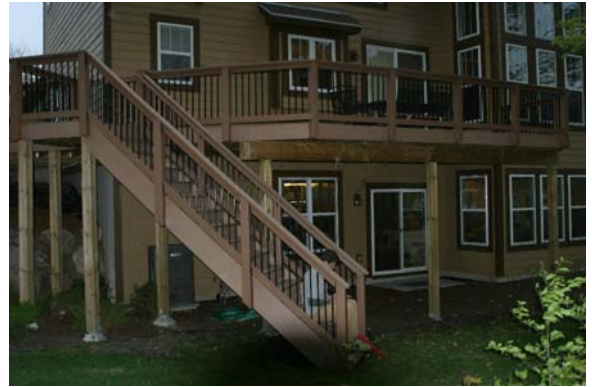
I reviewed the deck installed at the aforementioned address on 5/4/10 for any indications of movement that may be attributable to the use of the Diamond Pier foundation system.

The Diamond Piers were reviewed for distress around the pin sleeves or if the pins have moved relative to the pier. No signs of distress or cracking were observed. All pins project consistently from the Diamond Piers. A sampling of the pins indicates none are loose and a measurement down the inside indicates the pins are 50 inches long. An 8-inch bullet level was used to measure the levelness of the Diamond Pier. All were level. The post connection brackets were secure and fully seated on all Diamond Piers.

**There are no indications of any foundation movement or degrading of the structure.**

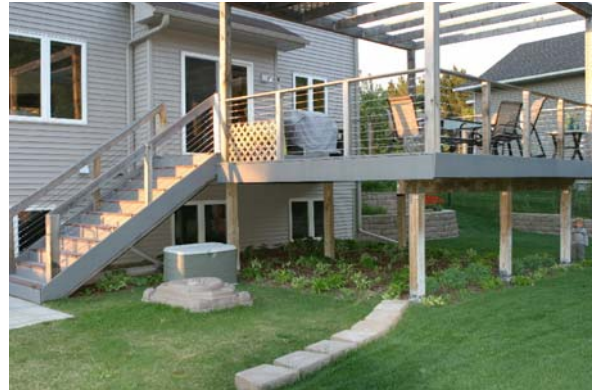
The deck in question is roughly 19 feet by 20 feet and 6 feet in height with a stairway. Two beams support the deck parallel to the back of the house; one eight feet from the house and the second at perimeter. Three piers support each beam. The deck has a trellis structure above. The soil on site is stiff clay.

The Diamond Piers were reviewed for distress around the pin sleeves or if the pins have moved relative to the pier. No signs of distress or cracking were observed. All caps covering the ends of the pins have been sealed to the concrete. The homeowner stated 48 inch pins were used on the project.

All Diamond Piers were level and the post connection brackets were secure and flat against the top of the pier. A 4- foot level was used to check the levelness of the joists and supporting beams. All posts are plumb and the supporting beams between the piers are level and tightly secured to the posts. I observed that the perimeter beam appears to have rolled slightly at the southeast end. The homeowner acknowledges that this occurred during construction because he had not joined the two plies of the beam together and the bracket at the top of the post bent. He has added a third ply to the beam and thru bolted all three members along the length of the beam. There is no indication of differential movement between the posts on either beam line.

**There are no indications of any foundation movement or degrading of the structure.**

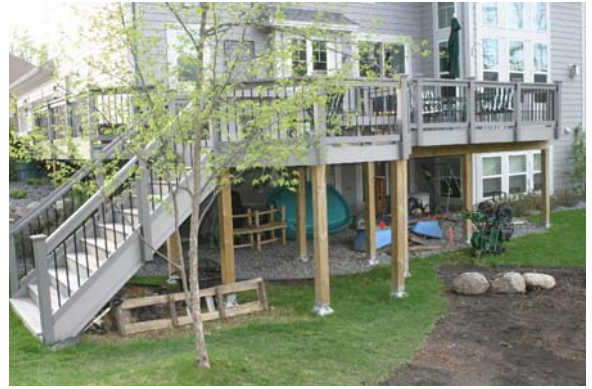
The main deck is roughly 22 feet by 14 feet and 12 feet in height. Three piers have been installed in a straight line along a common beam located approximately 13 feet from the house. Three additional piers support a walkway from the structure to the driveway on the side of the house and six piers support an octagonal landing leading to a stairway off the corner of the structure.

The Diamond Piers were reviewed for distress around the pin sleeves or if the pins have moved relative to the pier. No signs of distress or cracking were observed. Two pins of forty-eight on the site projected approximately 3/4" to 1" above the concrete while the remaining pins projected consistently from the Diamond Pier. A sampling of the pins indicates none are loose and measurements down the inside indicate the pins are 50 inches long. I used an 8-inch bullet level to measure the levelness of the Diamond Pier. All were level. The post connection brackets were secure and fully seated on all Diamond Piers.

**There are no indications of any foundation movement or degrading of the structure.**

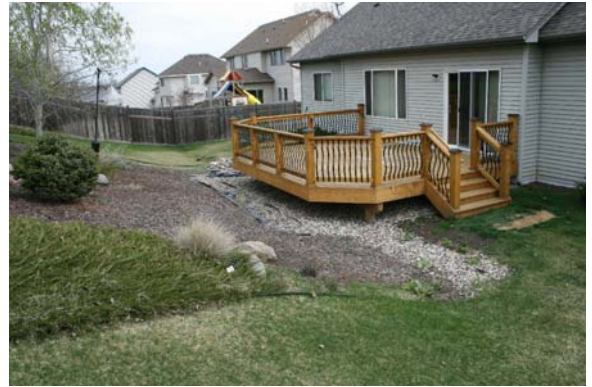
**Larson, Randy**

The deck in question is roughly 16 feet by 20 feet and 2 feet in height. Three piers support a common beam installed 14 feet from the house. The yard slopes towards the house and the homeowner reports that water saturates the soil around and under the deck as it drains from the hillside. The homeowner reports the site drains quickly and the soil is sandy and no water enters the basement of the house after heavy rains.

The piers were buried underground and the low deck made access difficult. I was able to observe one pier and its pins. The pier was not damaged and the pin projection is consistent with that found on other projects. None of the pins are loose and a measurement down the inside indicates 63 inch pins were used on the project.

**There are no indications of any foundation movement or degrading of the structure.**

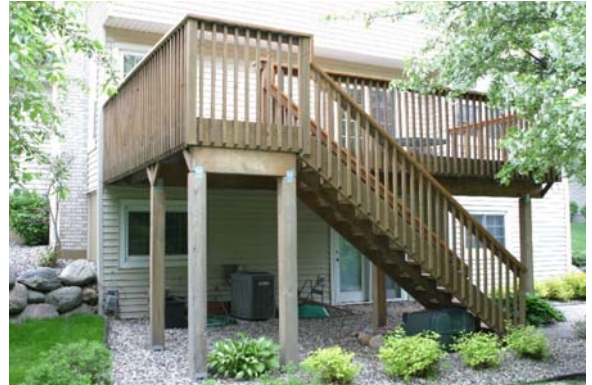
**Loven, Ron**

The deck in question is roughly 11 feet by 22 feet and 10 feet in height. Three piers support a common beam installed 10 feet from the house. Two additional piers are installed at a stair landing along the front of the deck. The yard slopes steeply away from the home towards a ravine approximately 35 feet from the deck.

The piers were all installed level and the pins project consistently from each pier. One pier has a slight spall around one pin. No cracking was observed. None of the pins are loose and a measurement down the inside indicates 60 inch pins were used on the project.

The post base brackets are level against the pier and the posts are tightly secured. The posts to beam connections are tight and no gaps were observed.

**There are no indications of any foundation movement or degrading of the structure.**

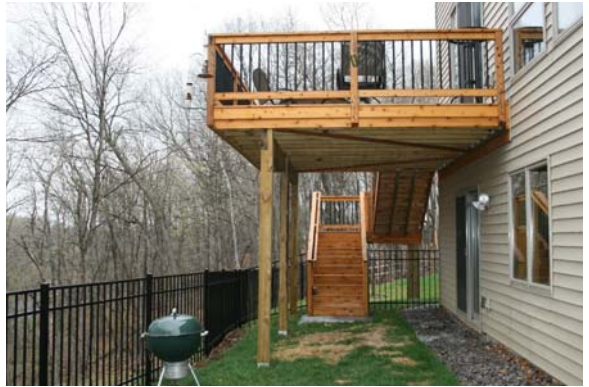
The deck in question is roughly 12 feet by 17 feet and 10 feet in height. Three piers have been installed in a straight line along a common beam located approximately 10 feet from the house. Four additional piers support a stairway from the structure. The site consists of a large engineered fill with a 15-foot tall rock retaining wall. No drainage issues are apparent.

The Diamond Piers were reviewed for distress around the pin sleeves or if the pins have moved relative to the pier. No signs of distress or cracking were observed and all the pins project consistently from the Diamond Pier. A sampling of the pins indicates none are loose and measurements down the inside indicate the pins are 50 inches long. An 8-inch bullet level was used to measure the levelness of the Diamond Pier. All were level. The post connection bracket was secure and fully seated on the Diamond Pier.

**There are no indications of any foundation movement or degrading of the structure.**

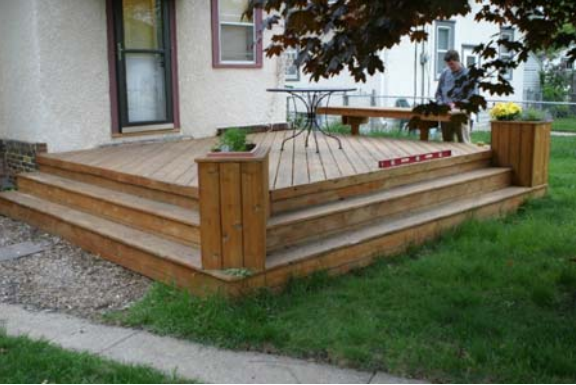
**Hanson, Laura**

The deck in question is 12 feet by 14 feet and 2 feet in height. The deck is freestanding and is not attached to the house. By code, footings extending to frost depth are not required for freestanding decks. The deck is supported by two beams with three Diamond Piers per beam. The first beam is located 2 feet from the house running parallel to the house. The second beam was located ten feet from and running parallel to the first beam.

All six piers observed, but access was restricted due to the height and finished sides of the deck. Two piers were reviewed: The first pier closest the house was level and two pin length measurements were taken: one pin length is 17 inches and the other is 29 inches. It appears a short pin was used in order to install the pier close to the house. The second pier was found to be approximately 1/2" out of level and the wood post does not bear fully on its connection bracket. But the post to beam connection was tight indicating that the pier was installed out of level and adjustments were made in the framing. One pin measurement was taken at this pier and the length is 33 inches.

A 4-foot level was used to check the levelness of the deck. The joists and decking are level, as are the supporting beams. No distress was observed in the framing joints, which would indicate that the second pier was installed out of level originally, and the framing compensated for the tilt of the pier.

**There are no indications of any foundation movement or degrading of the structure.**

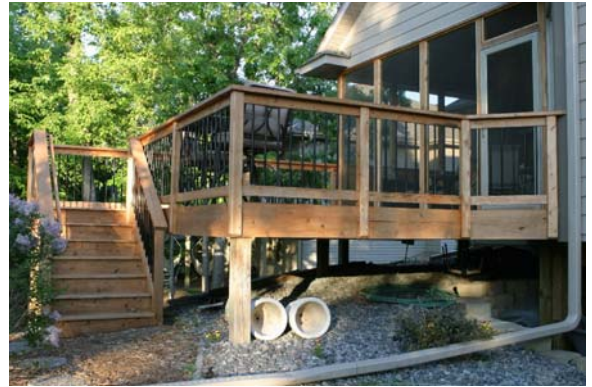
The structure supported by Diamond Piers is roughly 4 feet by 12 feet and 5 feet in height and is an addition to a deck set on conventional concrete piers. One diamond pier supports a beam which is framed into the existing structure. The two remaining piers support the landing of a stairway. The yard slopes steeply away from the home towards a ravine approximately 10 feet from the deck.

The piers were all installed level and the pins project consistently from each pier. None of the pins are loose and a measurement down the inside indicates 63 inch pins were used on the project. The post base brackets are level against the pier and the posts are tightly secured. The posts to beam connections are tight and no gaps were observed.

**In the portion of the structure supported on Diamond Piers, there are no indications of any foundation movement or degrading of the structure.**
